Metallized Coatings for Corrosion Control of Naval Ship Structures and Components

METALLIZED COATINGS FOR CORROSION CONTROL
OF NAVAL SHIP STRUCTURES AND COMPONENTS

Report of the
Committee on Thermal-Spray Coatings
for Corrosion Control

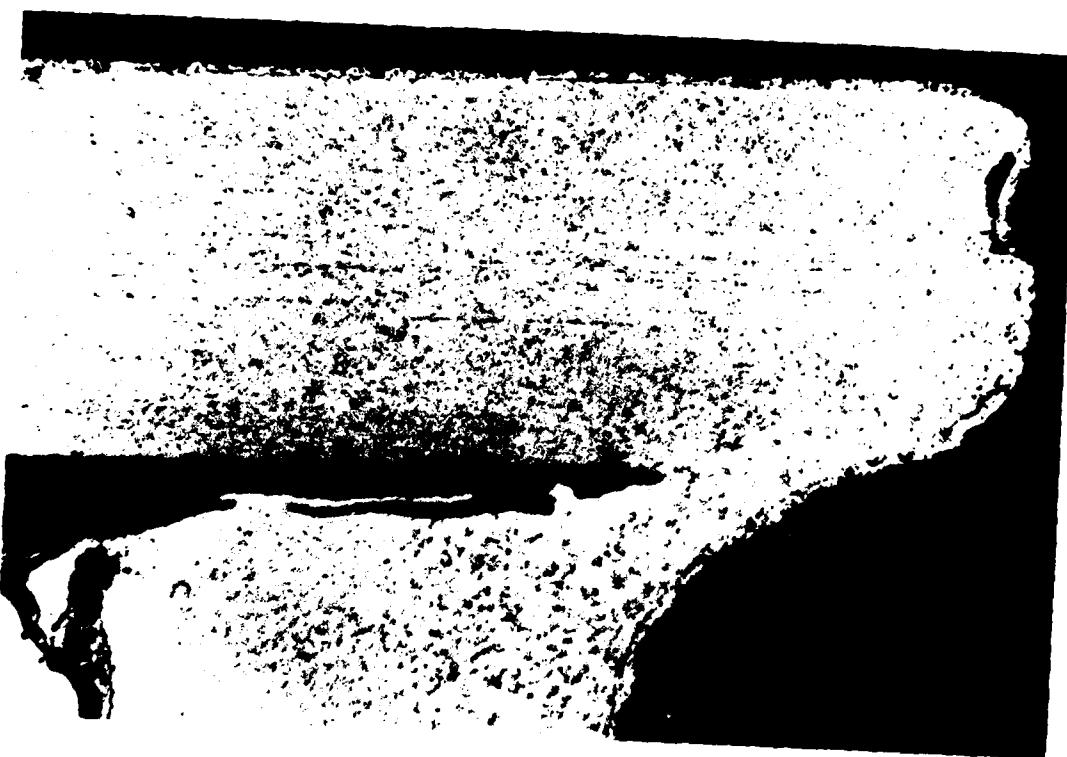
b. Continuous remaining coating on top above failure site.

FIGURE 3 Cross section of WSA-coated stanchion near site of local failure shown in Figure 2 (Courtesy Lockheed Missiles and Space Co.).

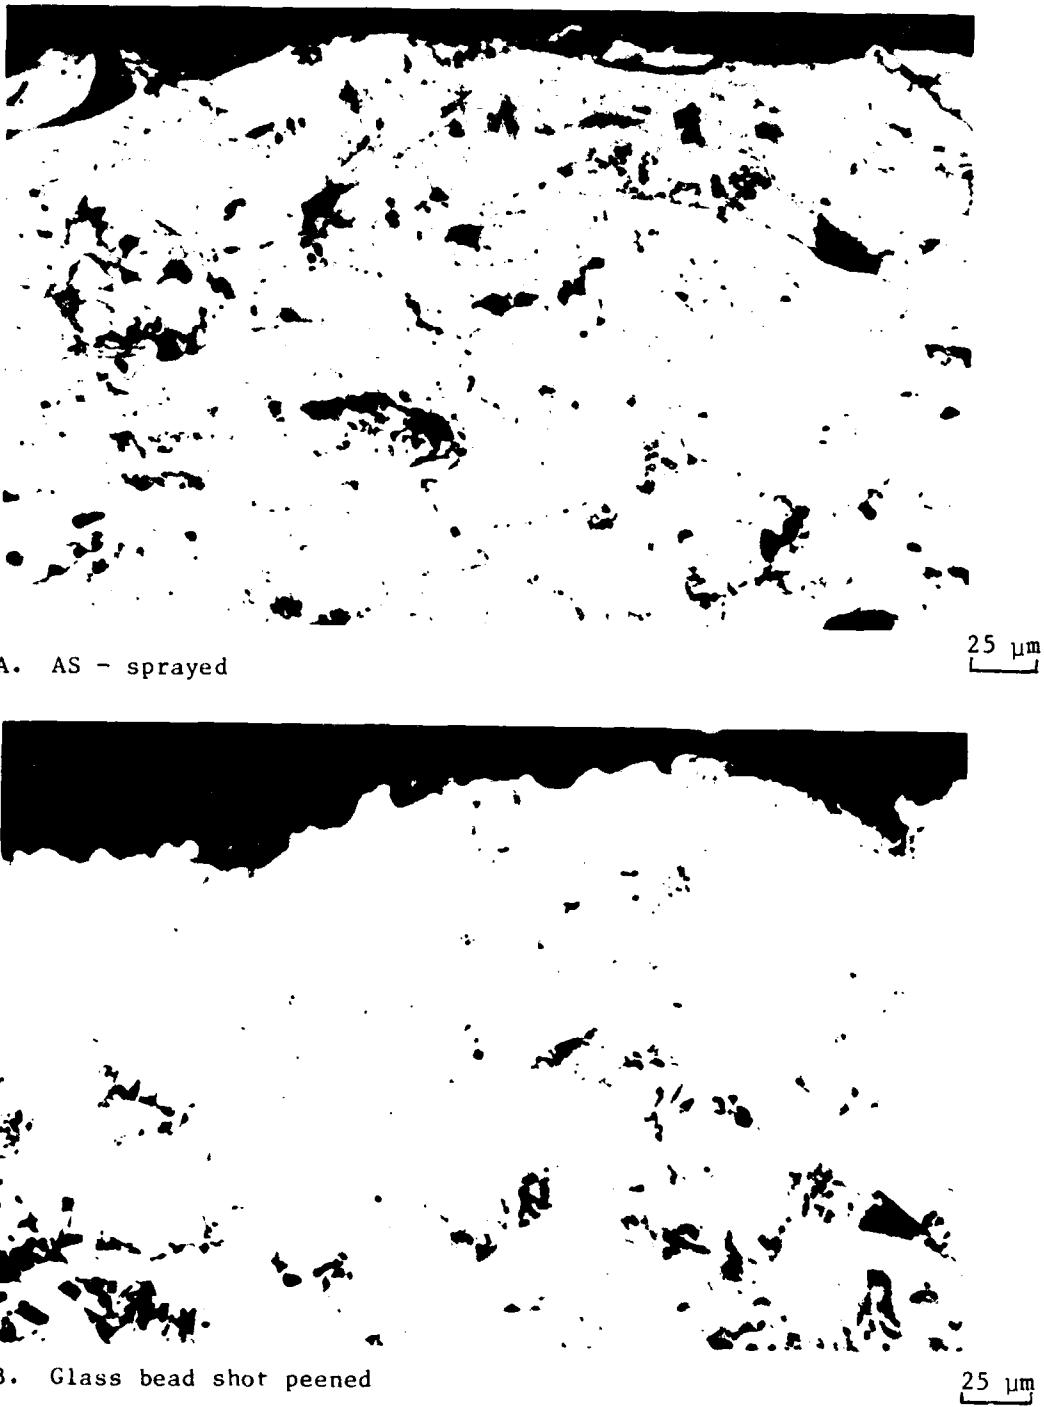
FIGURE 13 Densification of plasma sprayed aluminum coatings by glass bead shot peening (Courtesy of Lockheed Missiles and Space Company).

- o It is recommended that mechanical densification such as shot-blasting not be used to seal porosity due to a high potential for weakening or loss of bond. Shot or grit blasting also should not be used to remove paint from WSA coatings for the same reason. Surface cleaning by wire brushing is recommended.
